Proven Expertise

Large Valve Assessment and Rehabilitation

Valve Renewal Examples

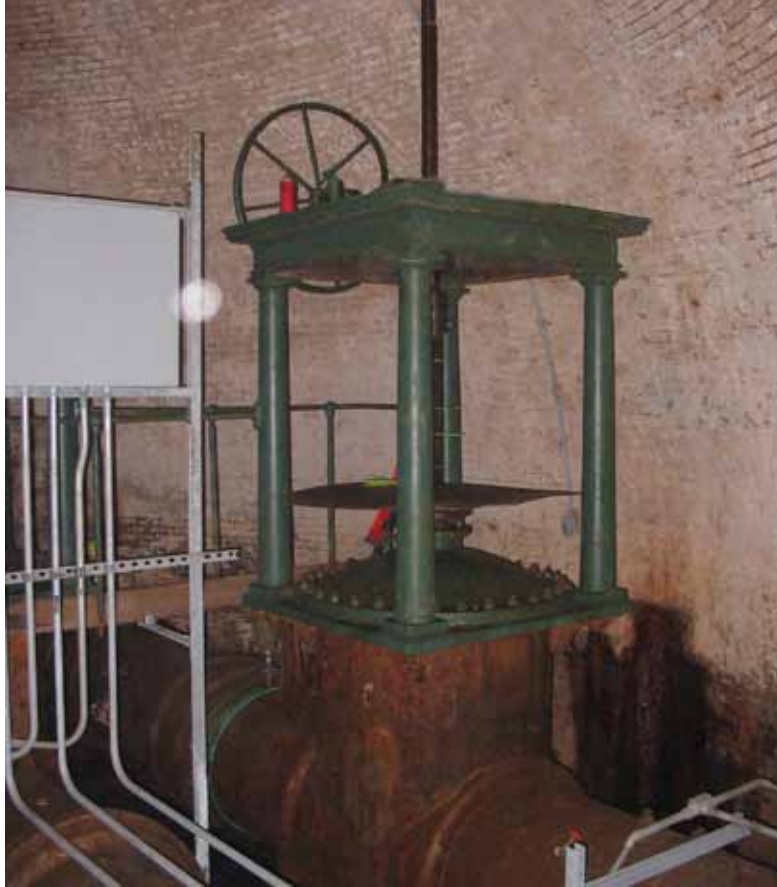
◀ Five large, externally geared, manually operated double disk gate valves were part of an 1874 reservoir construction program designed to protect the reservoir and downstream transmission system. On inspection, three of the five valves were found frozen. Through rehabilitation, testing and operation, all five valves are now operable and control the system as designed.

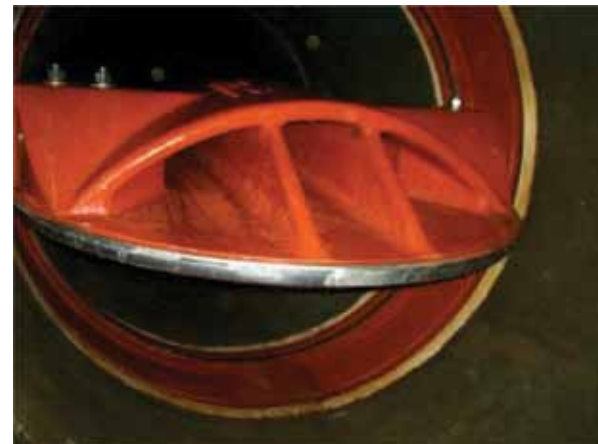
▲ This 72" butterfly valve did not hold when used on shutdowns. Wachs Water Services inspected the valve and determined that the valve seal had deteriorated. The valve seal was replaced and the valve seal and the valve stops were reset.

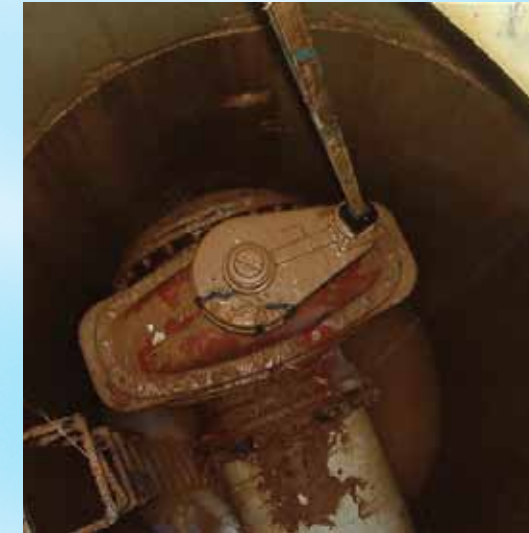
▲ This 54" butterfly valve was originally installed as a nonstandard operating valve (it turned to close in the opposite direction of the "standard close direction"). Wachs Water Services retrofitted the actuator so that it is a system consistent counter-clockwise standard operating valve.

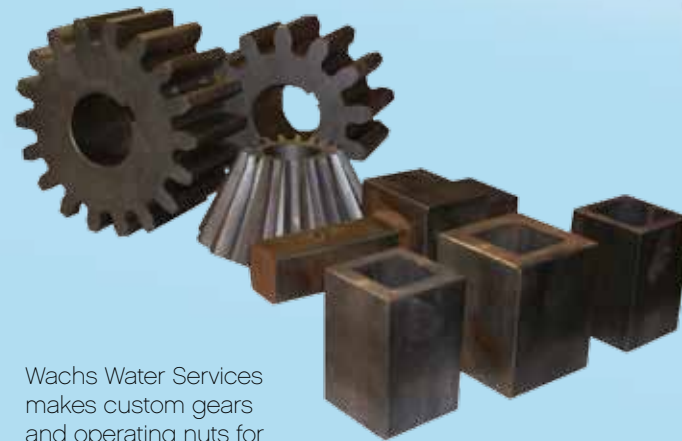
Wachs Water Services makes custom gears and operating nuts for large valve repairs. ▶

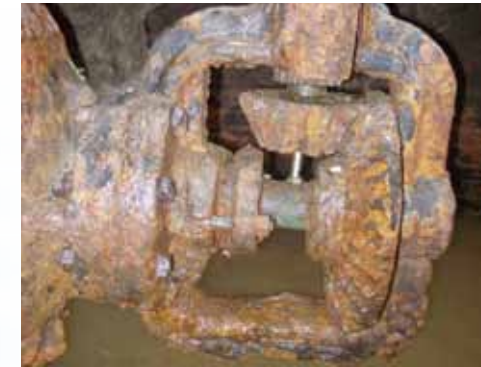
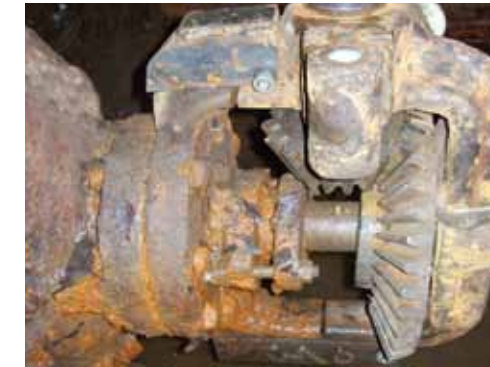
A pinion gear, bull gear, operating nut, pinion ring retainer, and pinion shaft were replaced on this 36" double disk gate valve. ▶

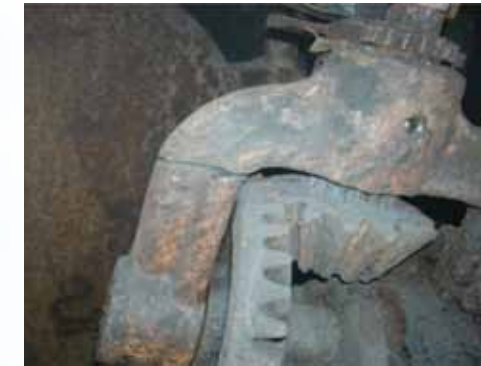
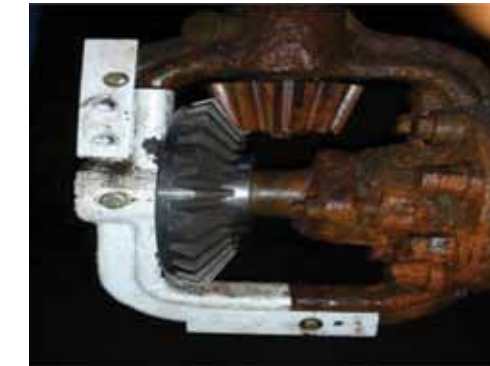
The fractured yoke was replaced on this 36" valve, restoring operability. ▶

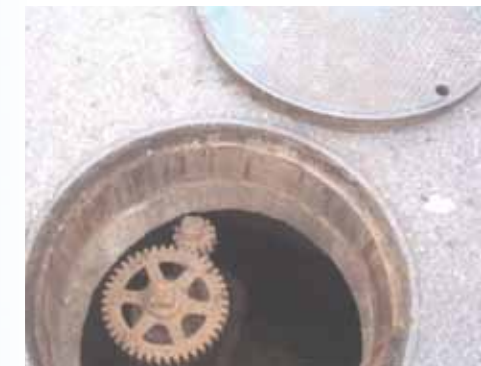
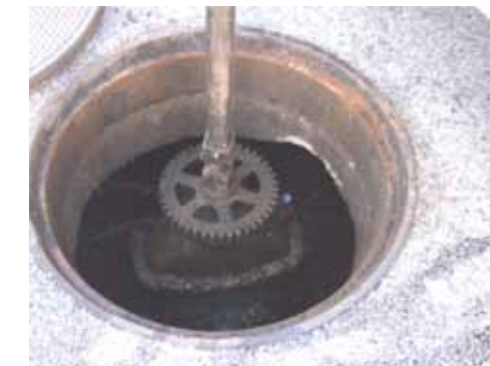
The small drive gear was frozen, fractured and failed on this 36" large double disk gate valve. The valve was rehabilitated by testing and operating the large drive gear, in a controlled and planned manner. The valve now operates fully using the large drive gear. ▶

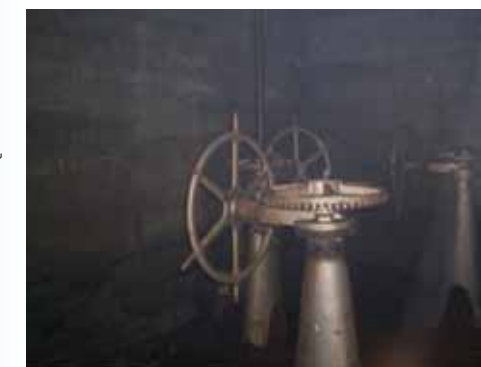
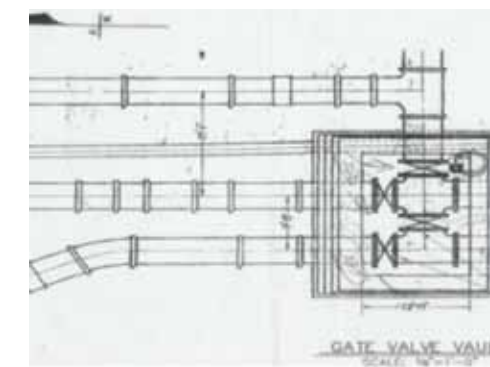
Two 48" rising stem gate valves that controlled the flow from a reservoir were inoperable. Both valves were disassembled, repaired and reassembled, with a pinion shaft replaced on one. ▶
